21st Century Chimney Sweep

6/30/2024 | 15 Photos

# 1223 Your St Chimney Report

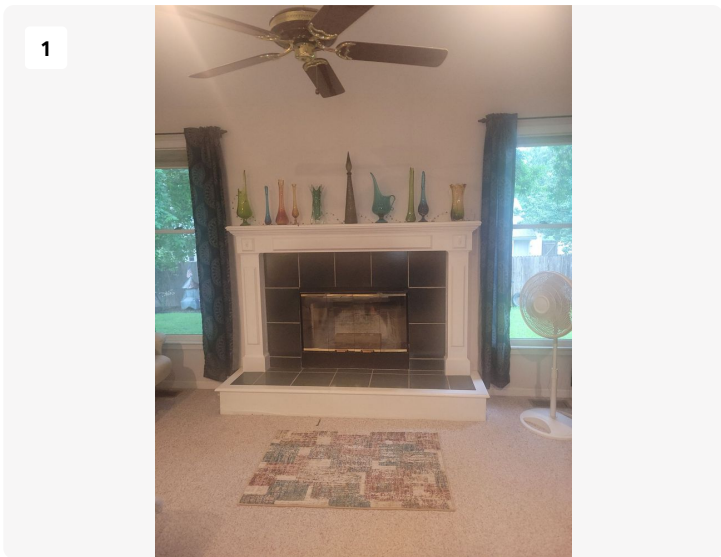
1 This is a factory built fireplace. It is intended to be a decorative appliance. While it was designed to contain a fire and exhaust the by products of combustion to the outside atmosphere this fireplace was not designed to be a home heat source. It should not be altered in any way and manufacturer's instructions should be precisely followed.

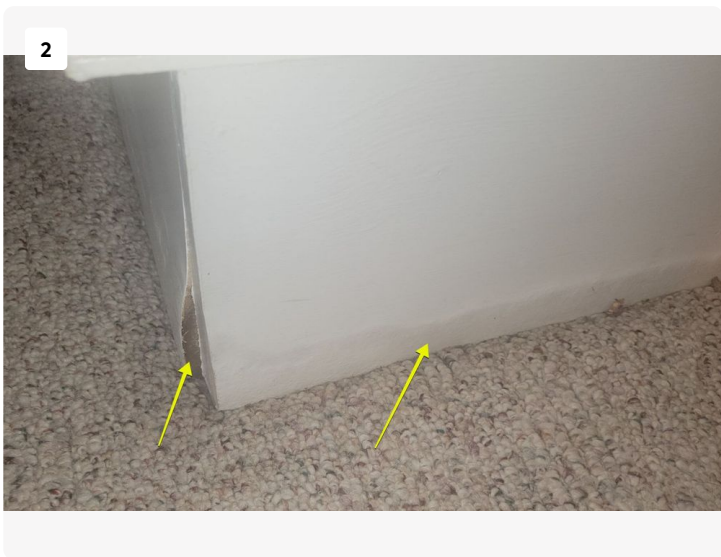
2 Water damage is present on the hearth extension in front of the fireplace. The wood is rotten.

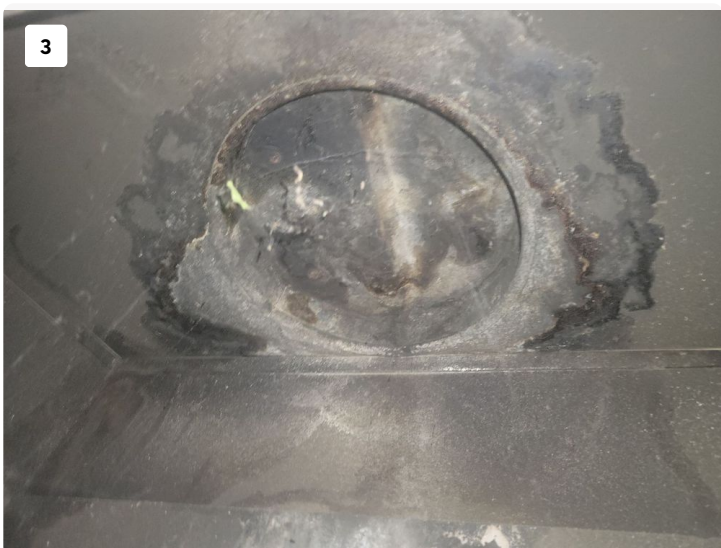
- The factory built fireplace system has had large amounts of water intrusion and has been damaged both inside and out. It is operationally deficient and potentially hazardous.

3 Discoloration near the damper is evidence of water intrusion. This will damage the system to some extent.

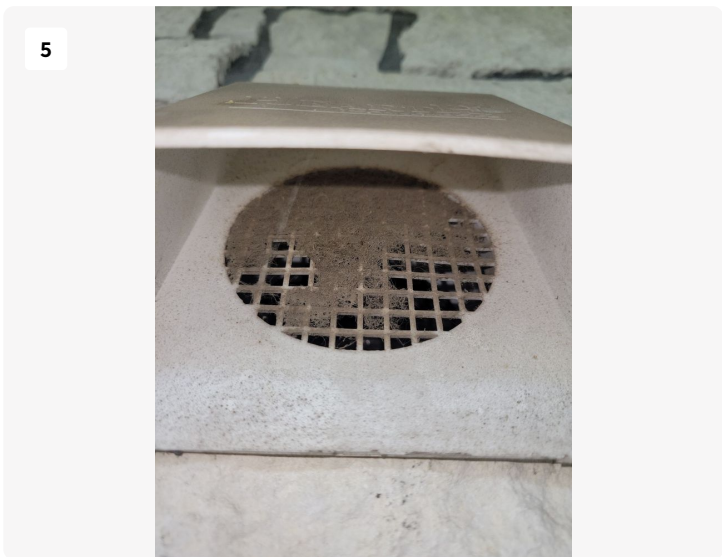
The air intake for outside combustion air is mostly plugged with dust. This will have a negative impact on performance.

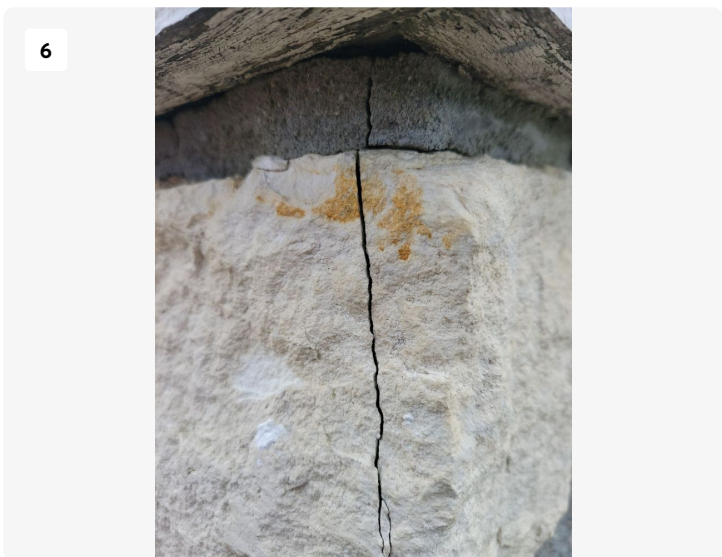
The stone veneer on the chase is stuck to a metal lathe, or screen. The screen is screwed to a substrate of some kind, typically plywood. Once water accesses the plywood it will begin to rot and the stone veneer will fail due to lack of support.

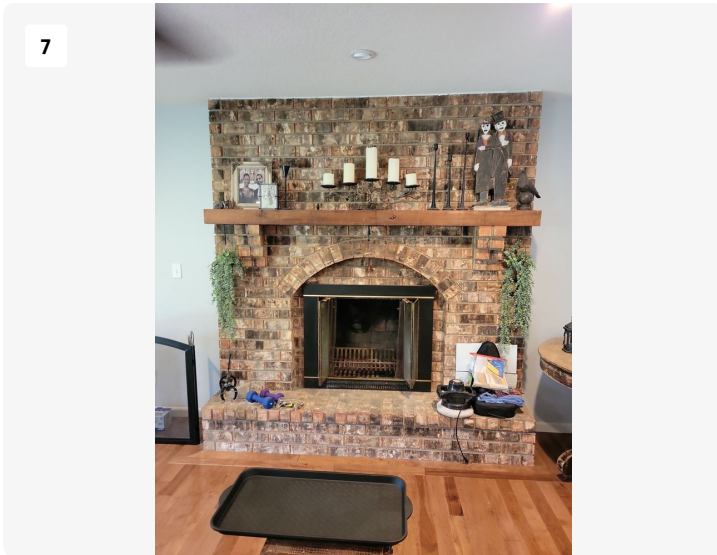
This is a standard masonry fireplace built (mostly) following guidelines from the Brick Institute of America that have not changed much if any in the last century. It is not as efficient as it could be nor as clean burning.

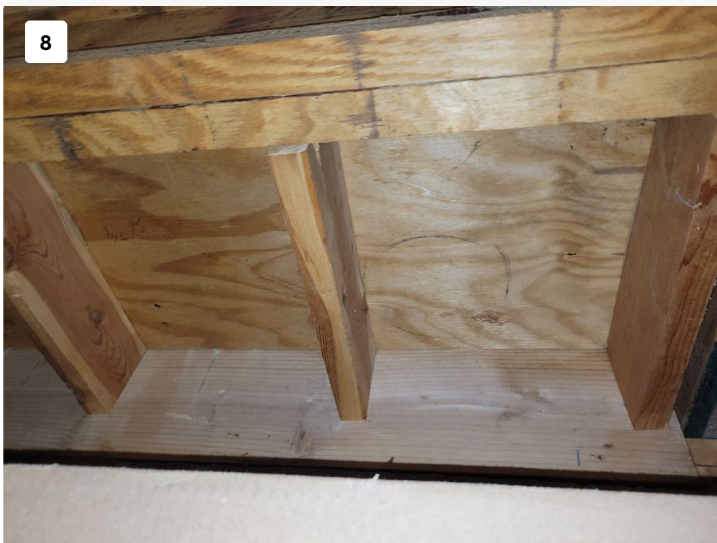
- Clearance to combustible materials is insufficient under the hearth extension and in the attic. When wood is exposed to heat pyrolysis occurs. Pyrolysis, or heat degradation, is a process by which the ignition temperature of wood is permanently reduced every time the wood gets hot. This literally means a structure fire becomes more likely to occur every time the fireplace is used.

The hearth extension is supported by wood forms. Wood should not be in this area, the hearth extension should be concrete poured as a self supporting slab extending from the chimney.

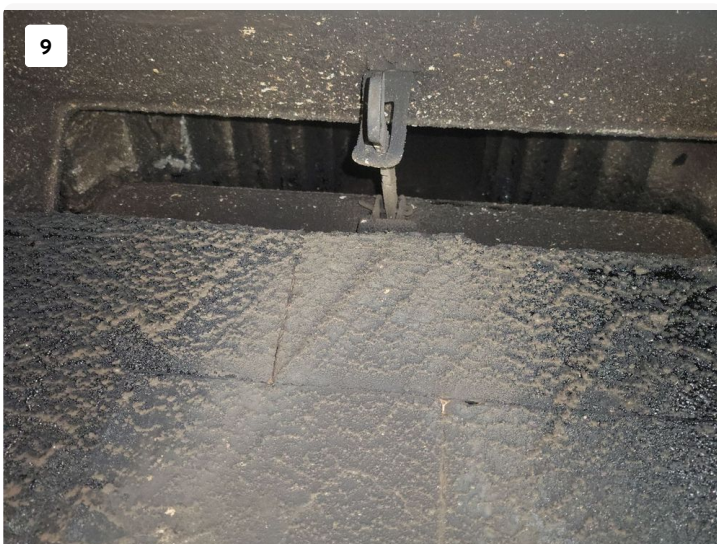
The smoke chamber is the area directly above the fireplace. It is like an upside down funnel connecting the large fireplace to the relatively small flue. The smoke chamber is not smooth. This creates turbulence in the flue gases which can cause poor performance and increases their residency time causing added creosote buildup. The smoke chamber should be completely smooth and well sealed.

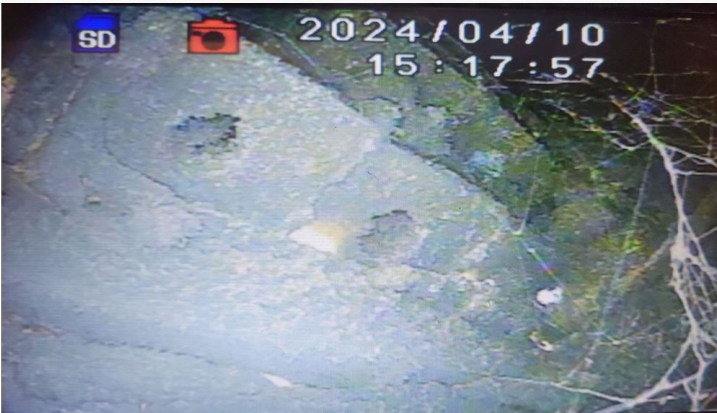
10

Through the open cells in these bricks the byproducts of combustion could escape their intended area and deposit flammable creosote in the cavity of the chimney.

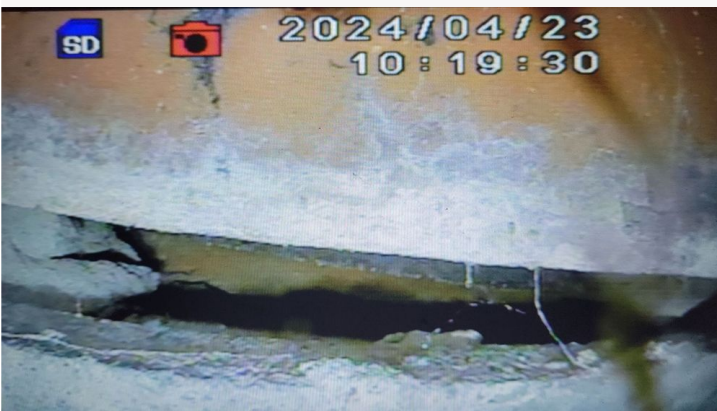
11

The flue is made up of terra cotta (clay) tiles. They are each 2 feet tall so there is a joint in the flue every two feet. This joint is sealed with mortar. Some of the joints between flue tiles have no mortar. This can allow the byproducts of combustion to escape the flue and deposit flammable creosote in the annular space of the chimney between the flue tiles and the exterior brick. This flue is compromised.

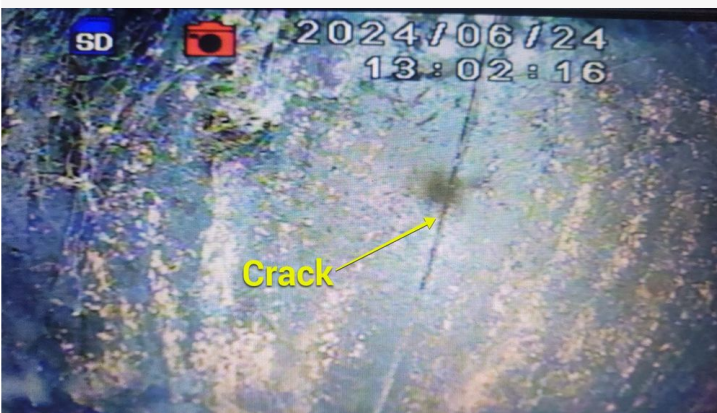
12

- Within the masonry system the cracking in the clay flue tile lining is consistent with thermal shock. Thermal shock happens when the inside of the tile is rapidly heated and expands faster than the outside of the tile, resulting in a vertical crack. Normal operation, and even over-firing, of the fireplace does not result in a rapid enough increase in heat to cause thermal shock. Thermal shock is typically associated with a chimney fire. A chimney fire is considered a sudden and accidental incident. There is substantial field evidence and some laboratory evidence that chimney fires can ignite and progress without ever developing the obvious signs associated with a free-burning fire. The reasons for and conditions necessary for such hidden fires are not well understood, partly because they may not be detected and observed while they are happening. Undoubtedly, they are related to the limiting but not total elimination of one or more of the vital elements of a fire: fuel,

Flue tiles crack due to thermal shock. During a high heat event the inside of the tile expands faster than the outside resulting in a vertical, or nearly vertical, crack.

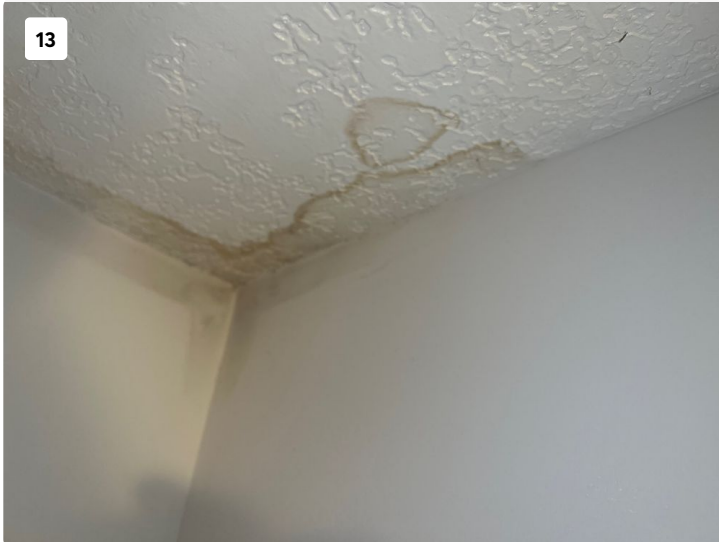
Water damage on the ceiling indicates water intrusion from the chimney.

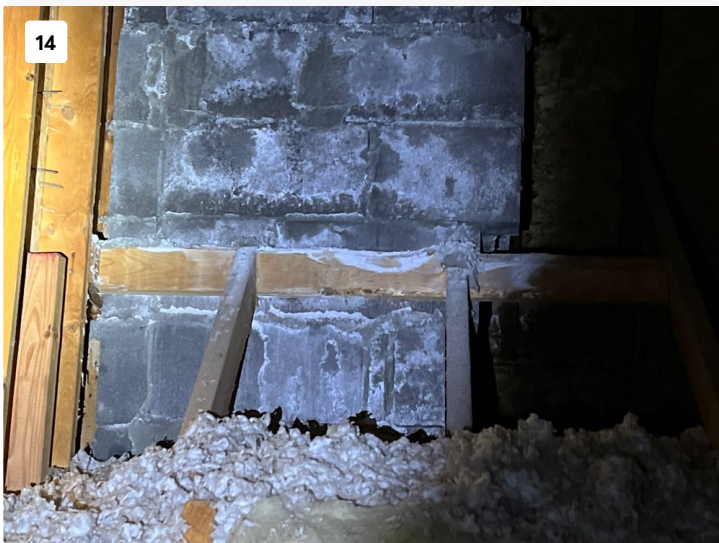
This picture is taken in the attic. The white stain is efflorescence. This is evidence of water intrusion. The stain is the salts and minerals that the water is picked up from the masonry and deposited here as it dried.

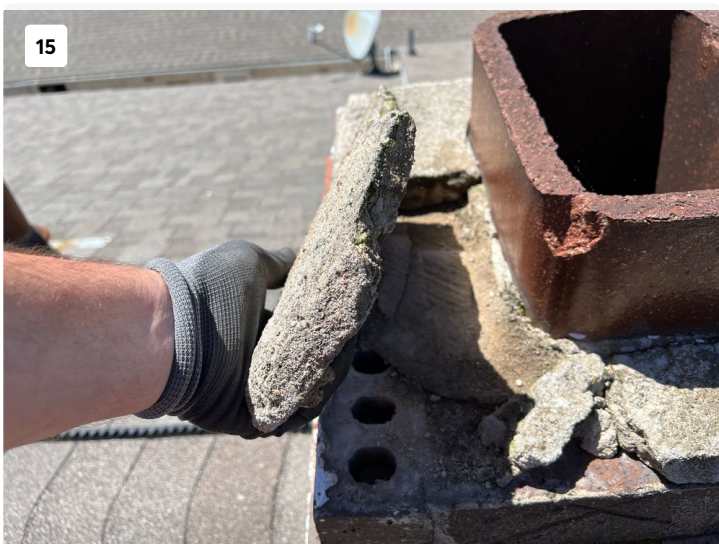
- Instead of a proper crown, this chimney has a mortar wash which is very common in this area. This mortar wash does not allow for any expansion/contraction of the chimney, the flue or the wash itself. This leads to cracking resulting in water intrusion, which is also very common. The mortar wash does not overhang the brick/stone face of the chimney. Mortar is meant to bond masonry units together, not to stand alone. A proper crown is made of concrete. It does have a bond break between the crown and the chimney and an expansion joint between the crown and the flue/flues. It has an overhang and a drip edge which prevent water from streaming down the face of the chimney causing deterioration and water intrusion. The purpose of the chimney crown is to close off the space between the flue liner and chimney wall, to shed rainwater clear of the chimney, and generally to prevent the entry of moisture. Despite its importance to the integrity of the chimney, this is one feature that is neither well addressed in codes nor well-executed in the field. Failed or inadequate chimney crowns are among the more common causes of chimney deterioration. (Chimney Fires; Causes, Effects & Evaluation)

The mortar wash on top does not adequately protect the chimney from water intrusion. It should overhang the face of the chimney to provide a drip edge keeping a majority of rain water off the face of the chimney. This is such a bad condition that parts of it can be removed by hand.
